La Preciosa Project

Preliminary Mineability Assessment

Submitted to: Orko Silver
Date: April 13 2012
From: Stephen Godden, AMEC

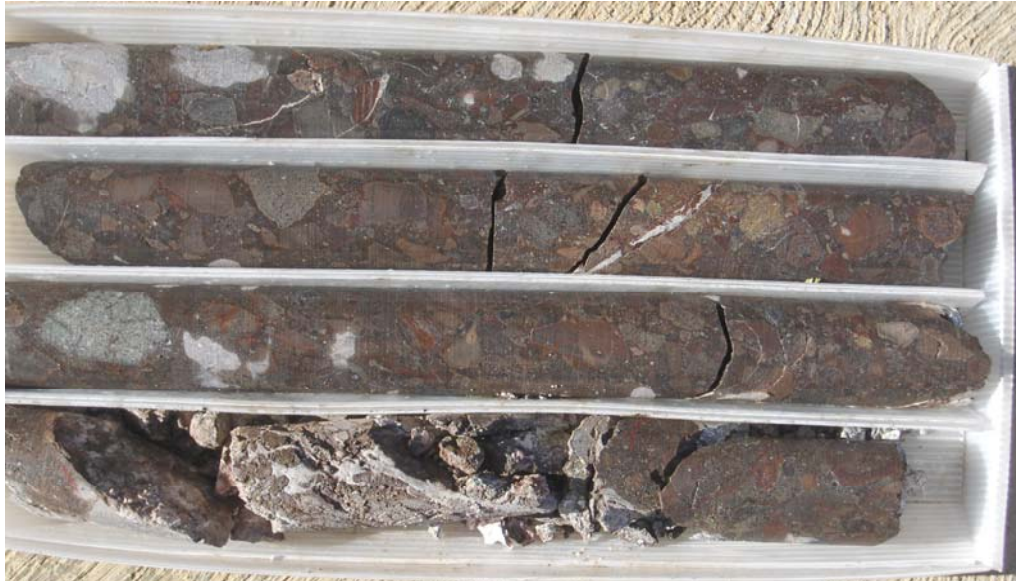
Figure 4: A Healed but Slightly Weathered Open Void Structure

*(note the lack of wallrock alteration/weathering in the andesite agglomerate wallrocks)
(drillhole BP05-022, 86.94 m to 89.12 m, top of section at top left)
(taken during AMEC's January/February 2012 site visit)*

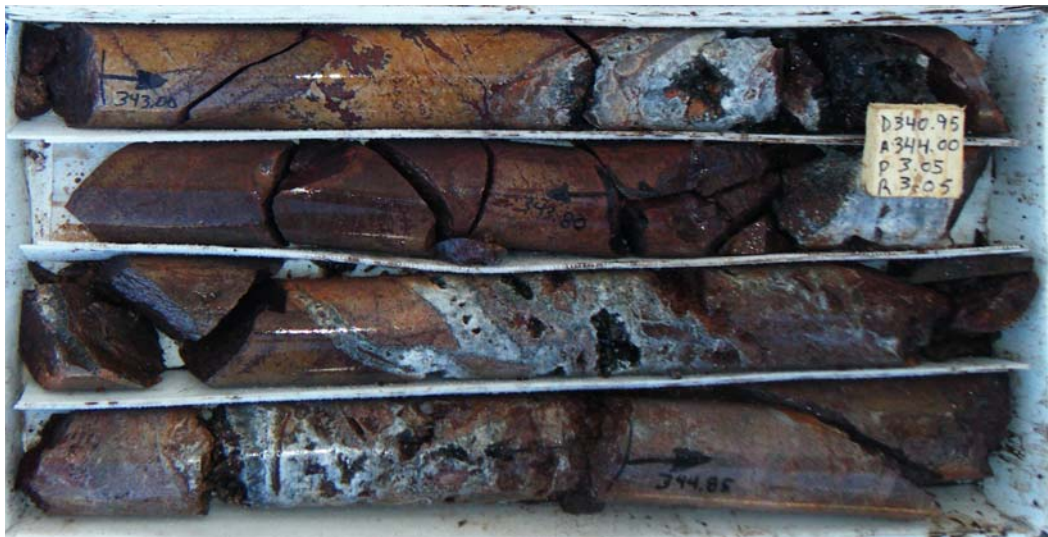
Figure 5: Coarse Crystalline Infillings in Open Void Structures in a Section of Weakly (hematite) Altered Andesite

*(drillhole BP10-673, 343.00 m to 345.10 m, top of section at top left)
(taken shortly after the hole was drilled, supplied by Pan American)*

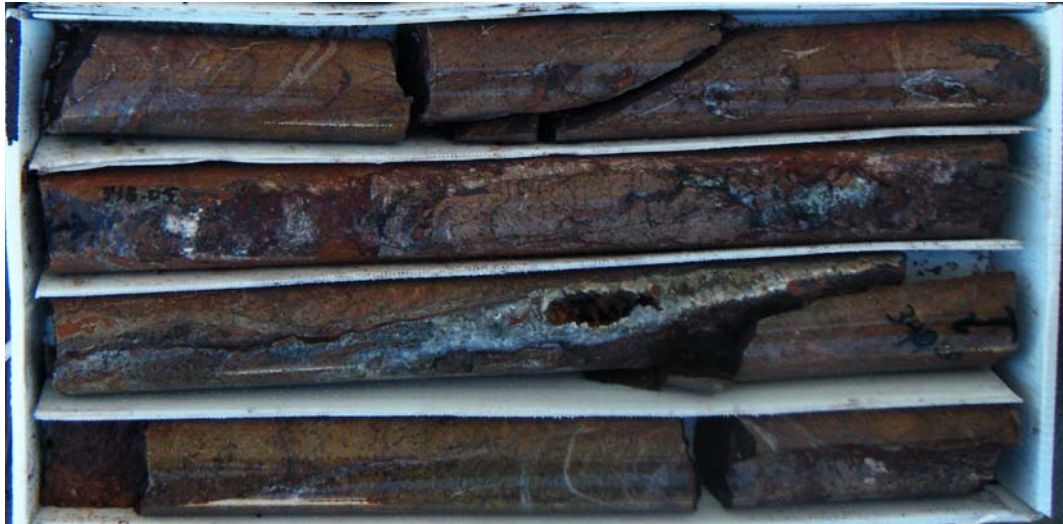
Figure 6: An Undulating and Steeply Inclined to Sub-Vertical Discontinuity with Well-Developed, Open Void Mineral Growth

*(drillhole BP10-673, 347.45 m to 349.85 m, top of section at top left)
(taken shortly after the hole was drilled, supplied by Pan American)*

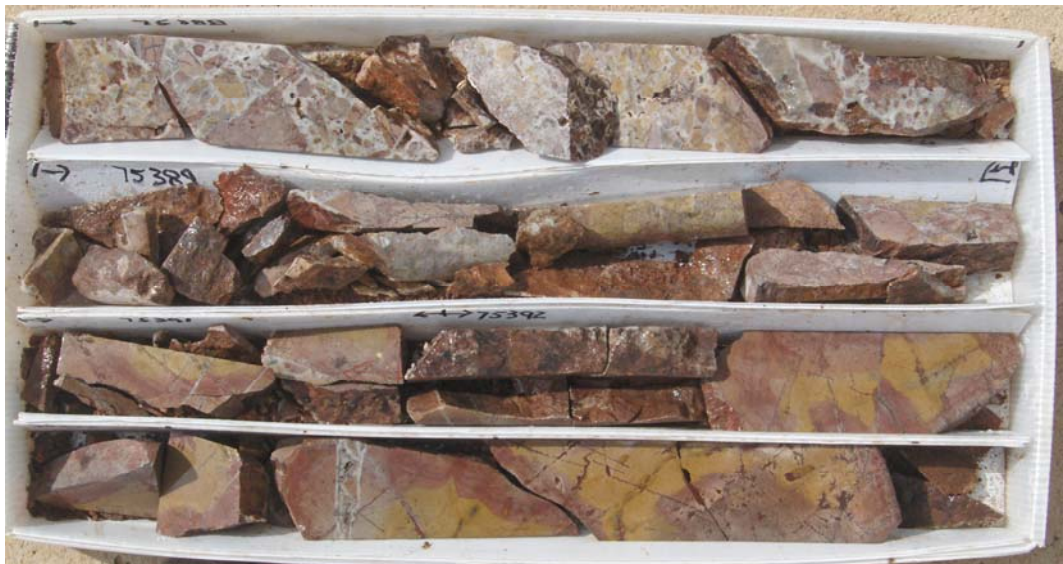
Figure 7: An Example of a Steeply Inclined, Undulating and Rough, Unmineralized but Limonite-Stained, Open Joint in Association with a Silicified Vein Intersection and a Hematite-Altered and Slightly Weathered / Leached Andesite

*(note the drilling-related damage to the core along which the discontinuity is developed)
(drillhole BP05-022, 86.94 m to 89.12 m top of section at top left)
(taken during AMEC's January/February 2012 site visit)*

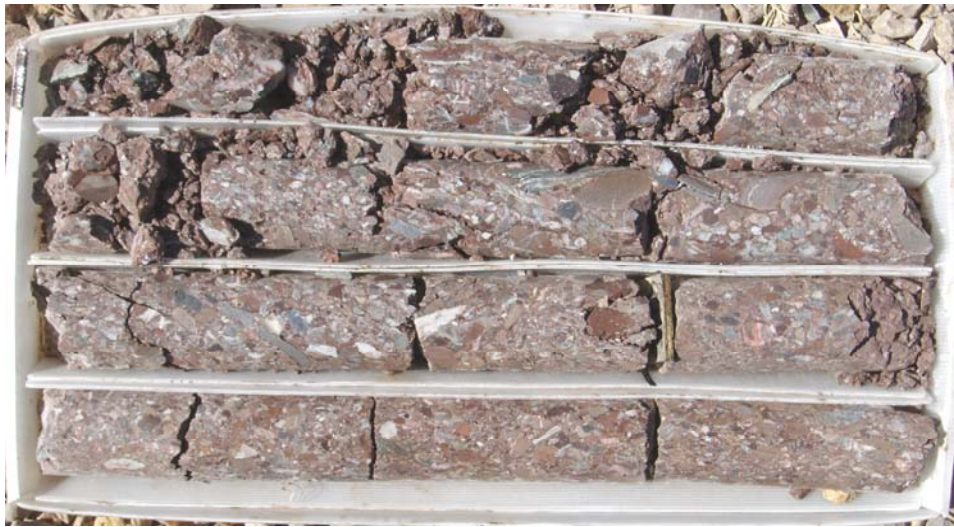
Figure 10: An Example of Progressive Degradation of a Weathering-Susceptible Section of Unaltered Breccia of the Breccio-Conglomerate Sequence

(drillhole BB05-06, 91.55 m to 93.69 m, top of section at top left)
(taken during AMEC's January/February 2012 site visit)

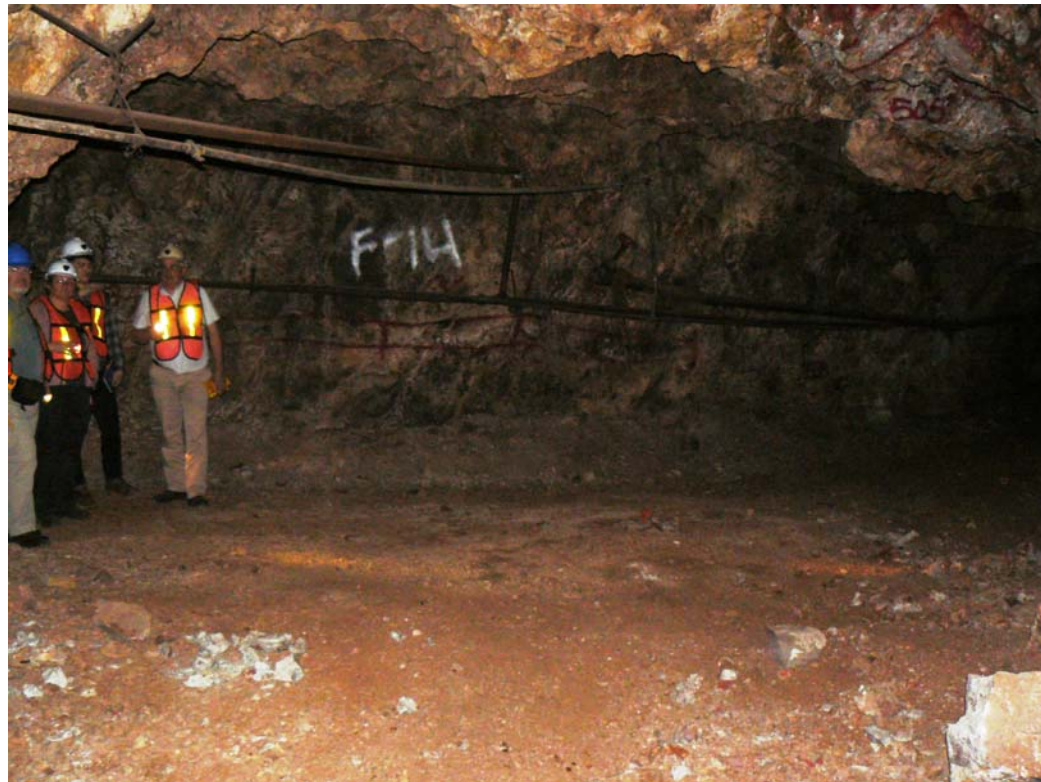
Figure 16: A General View, Looking Approximately West) of the Large Span Intersection Area Where A Crosscut Meets the Adundancia Vein Drift
(note the lack of any support and the limited amount fallen material on the footwall of the drift)
(taken during AMEC's early January 2012 site visit)

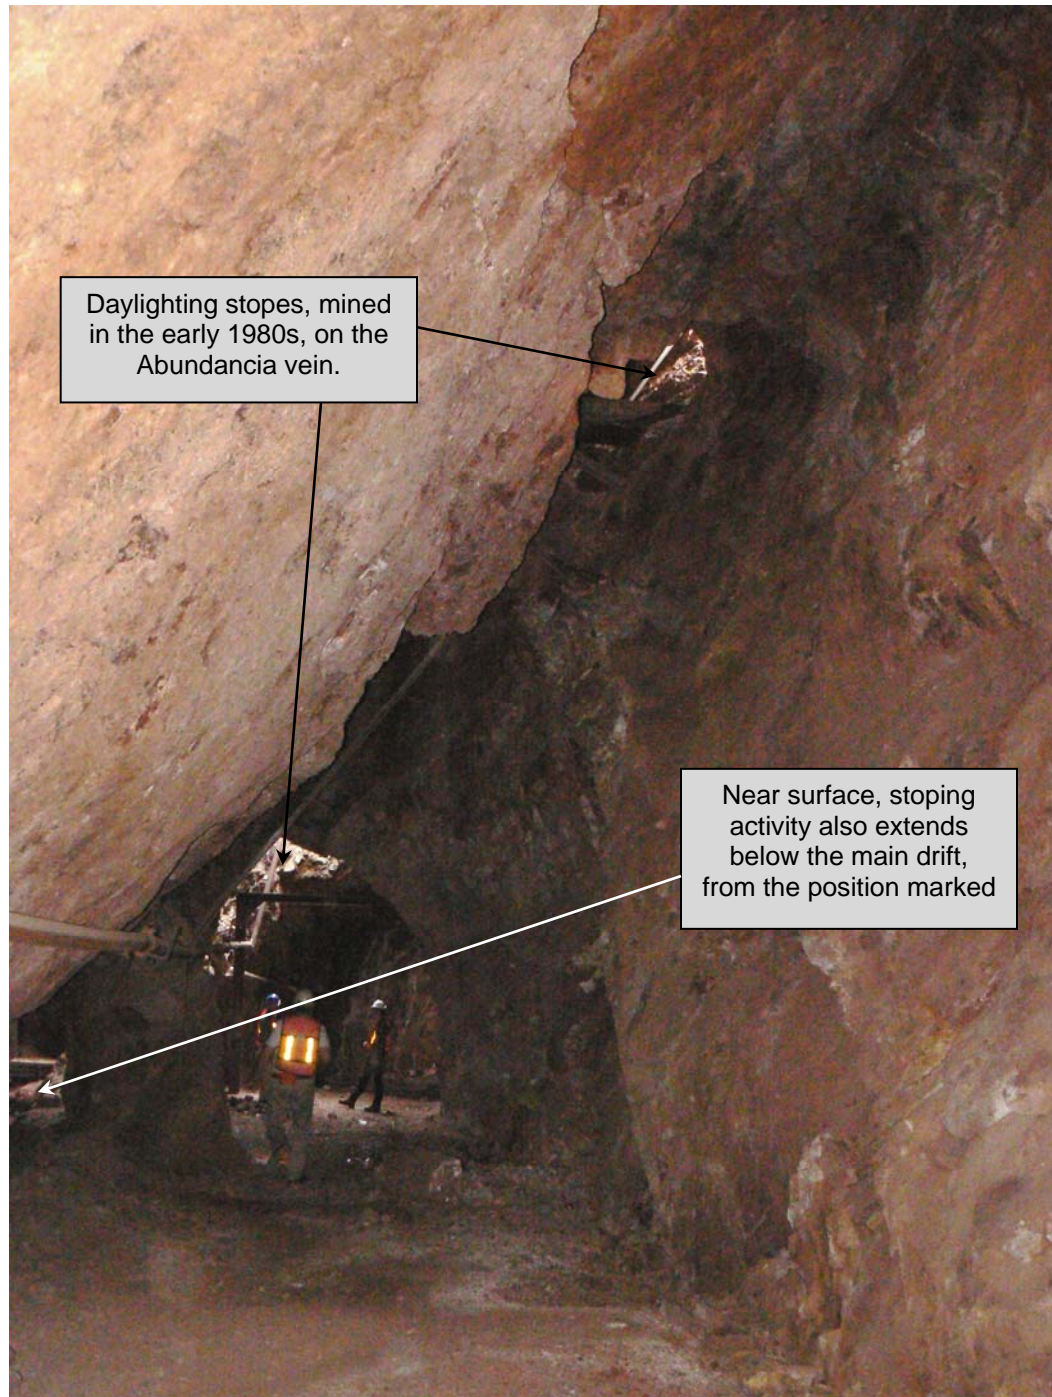
Figure 17: A General View, Looking Approximately North, of Some of the Near Surface and Large Span, Abundancia Vein Stopes in the Historical La Preciosa Workings

*(note the lack of any support and lack of any fallen material on the footwall of the drive)
(taken during AMEC's early January 2012 site visit)*

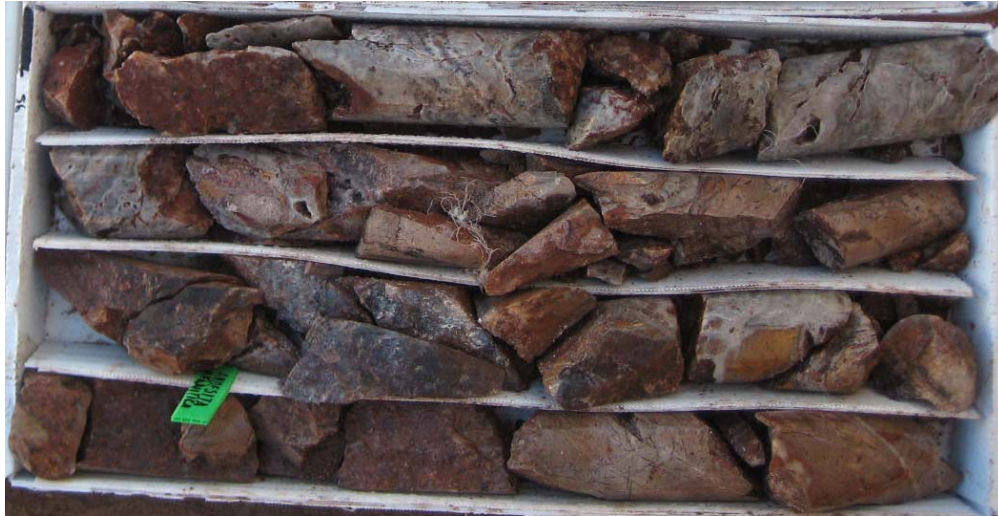
Figure 20: An Example of Extensively Drilling-Damaged Vein Material, due to the Presence of Minor Vugs and, Most Importantly, Sub-Vertical, Open Joints
(drillhole BP10-467, 121.80 m to 123.95 m)
(taken in 2010, shortly after the hole was drilled, photolog supplied by Pan American)

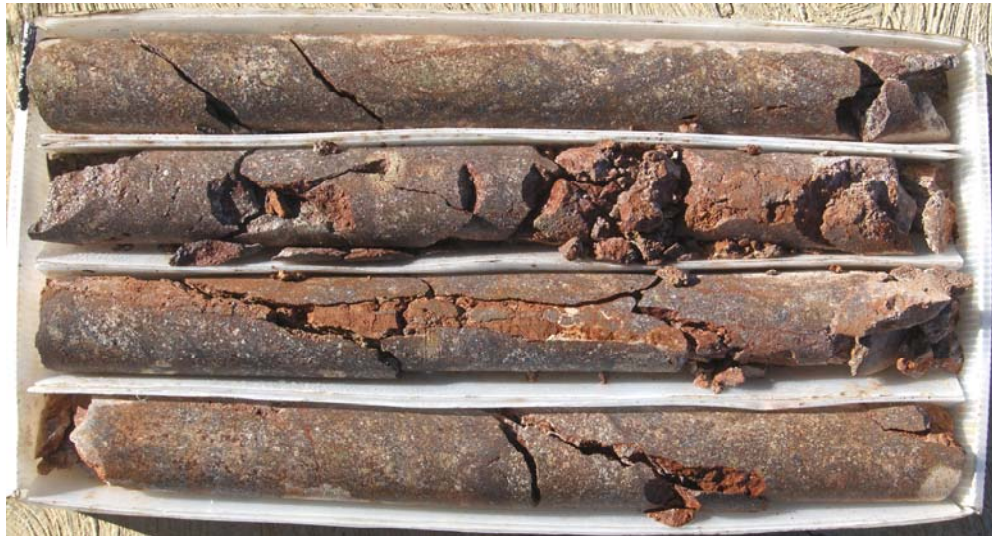
Figure 21: Sub-Vertical and Undulating Open Void Joint with Thick Limonite Infillings
(drillhole BP08-254, 7.95 m to 10.16 m, top of section at top left)
(taken during AMEC's January/February 2012 site visit)

Figures 21 & 22 also demonstrate that porphyritic andesite of the LVS and the breccio-conglomerates of the early Cretaceous sedimentary sequence tend to be weathering resistant (the extent of wallrock alteration / leaching below the main weathered zone is typically very limited). The exceptions include zones where clay mineral assemblages are present in the sedimentary sequence (for example, Figure 9 above) or where intense alteration activity is locally developed (Section 5.3). Very occasionally, clay-rich infillings can also infrequently be found along discrete discontinuities in the sedimentary sequence (for example, Figure 23), which suggests locally above-average groundwater penetration, or even flow, along open discontinuities.

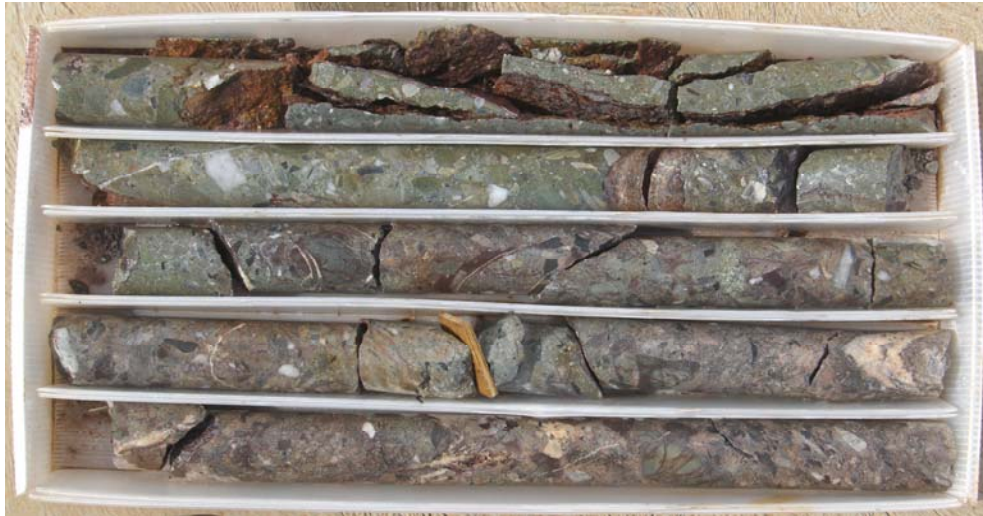
Figure 22: Sub-Vertical and Undulating Open Void Joint with Minor Limonite Infilling
(drillhole BP08-266, 320.26 m to 323.01 m, top of section at top left)
(taken during AMEC's January/February 2012 site visit)

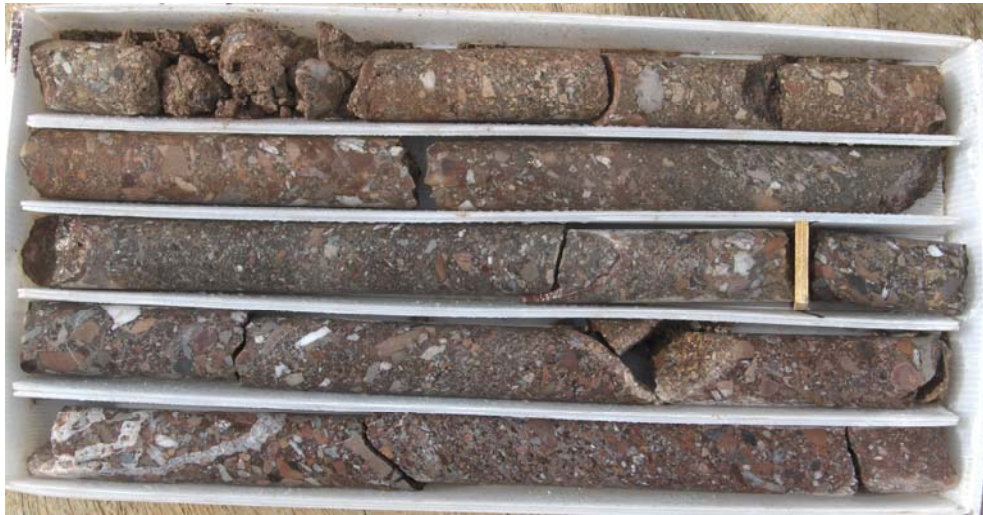
Figure 23: A Rare Example of Severe Local Weathering of Otherwise Intact and Fresh Breccio-Conglomerate, the Former as Marked by the Clay-Rich Material Near the Top of the Drillcore Section
(drillhole BP08-266, 158.99 m to 161.88 m, top of section at top left)
(taken during AMEC's January/February 2012 site visit)

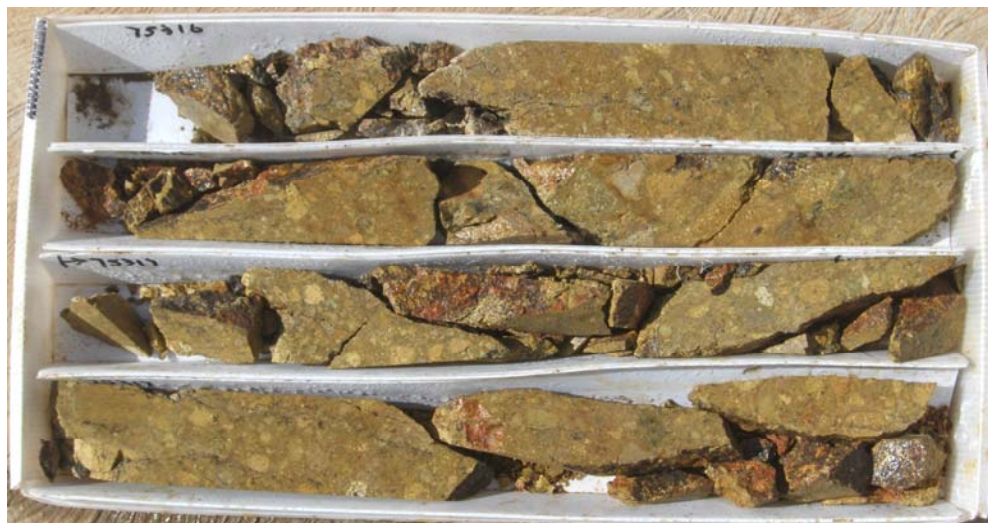
Figure 25: An Example of Selectively but Deeply Weathered / Leached Andesite Agglomerate of the LVS, in a Zone Affected by Sub-Vertical Open Joints (marked by limonite infillings) Approximately 50 m below the Base of the Main Surface Weathered Zone
(drillhole BP08-211, 63.98 m to 66.35 m, top of section at top left)
(taken during AMEC's January/February 2012 site visit)

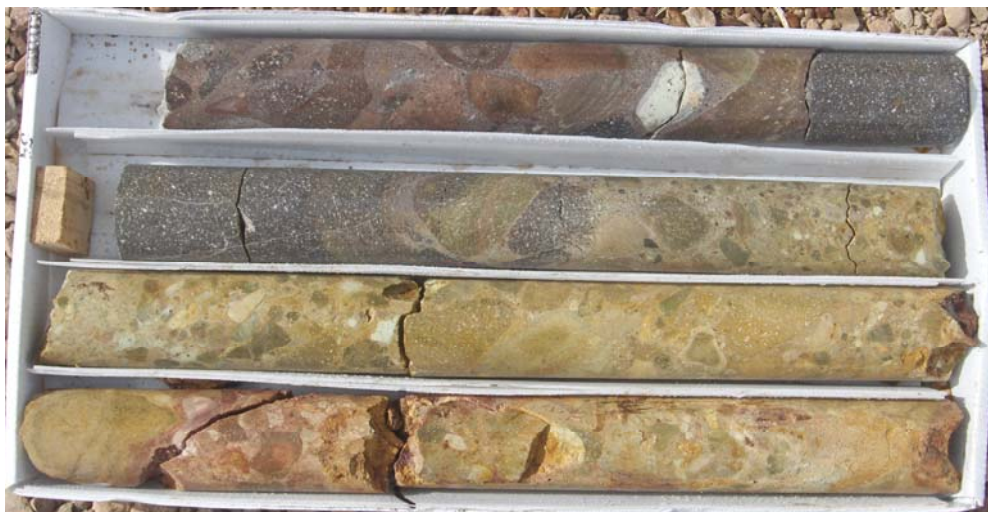
Figure 26: An Example of Selectively and Slightly Weathered / Leached Andesite Agglomerate of the LVS, in a Zone of Otherwise Massive, Fresh and Unweathered Material
(drillhole BP10-673, 116.40 m to 118.65 m, top of section at top left)
(taken during AMEC's January/February 2012 site visit)

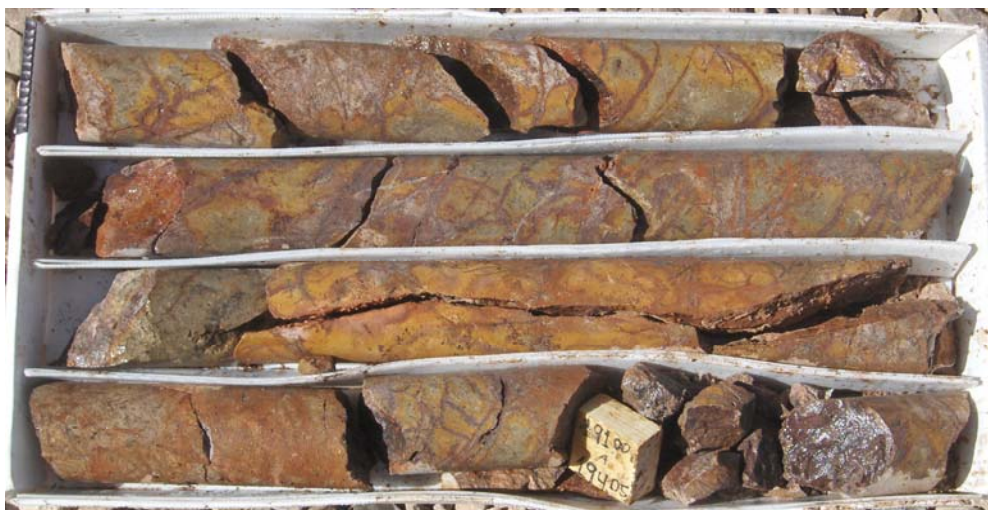
Figure 27: An Example of Selectively and Slightly Weathered / Leached Andesite Agglomerate of the LVS, in a Zone of Micro-Fracturing Associated with Hematite Alteration
(drillhole BP10-560, 192.35 m to 194.35 m, top of section at top left)
(taken during AMEC's January/February 2012 site visit)

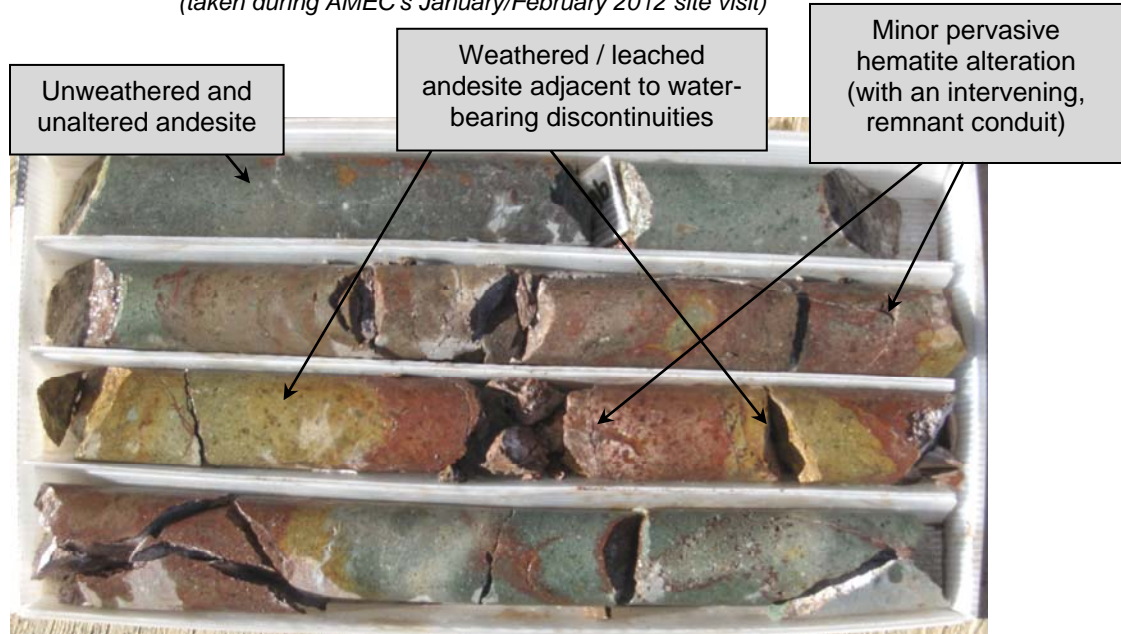
Figure 29: An Example of Minor Pervasive Hematite Alteration and Wallrock Weathering (leaching) of Andesite Tuff of the LVS
(drillhole BB05-022, 95.70 m to 97.80 m, top of section at top left)
(taken during AMEC's January/February 2012 site visit)

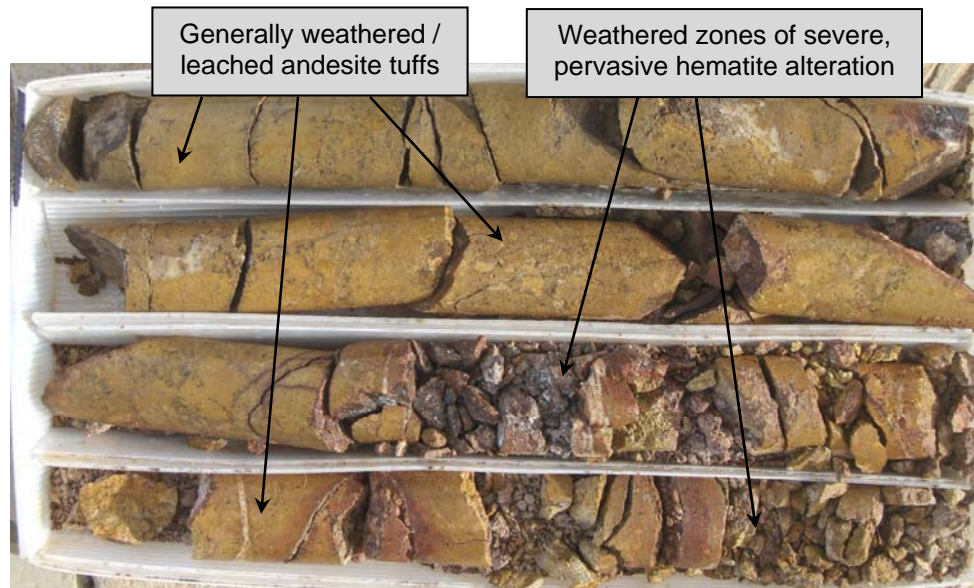
Figure 30: An Example of Surface Weathering Effects on Minor Zones of Pervasive Hematite Alteration within a Generally Weathered (leached) Section of Andesite Tuff of the Lower Volcanic Series
(drillhole BP06-079, 133.50 m to 135.71 m, top of section at top left)
(taken during AMEC's January/February 2012 site visit)

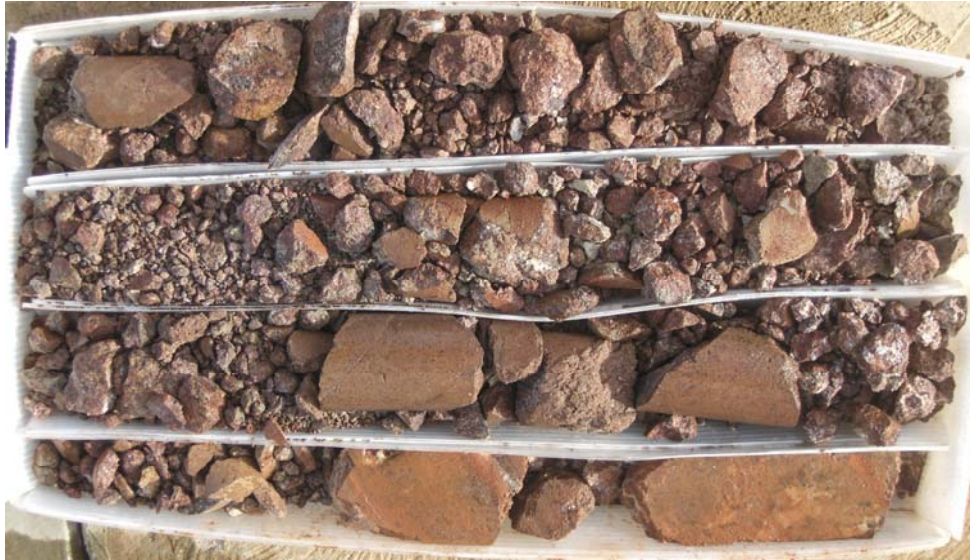
Figure 31: An Example of In situ Weathering Effects and In-Box Degradation of a Zone of Severe and Pervasive Hematite Alteration of Porphyritic Andesite of the Lower Volcanic Series

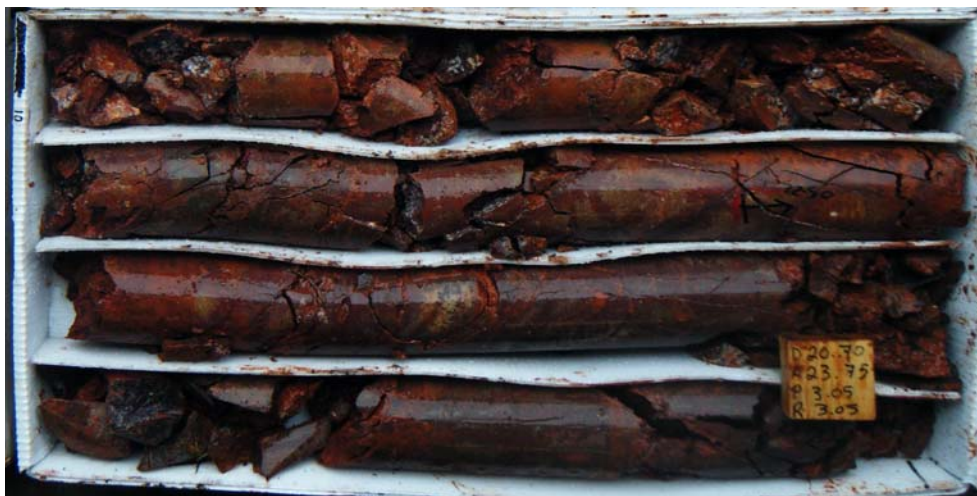
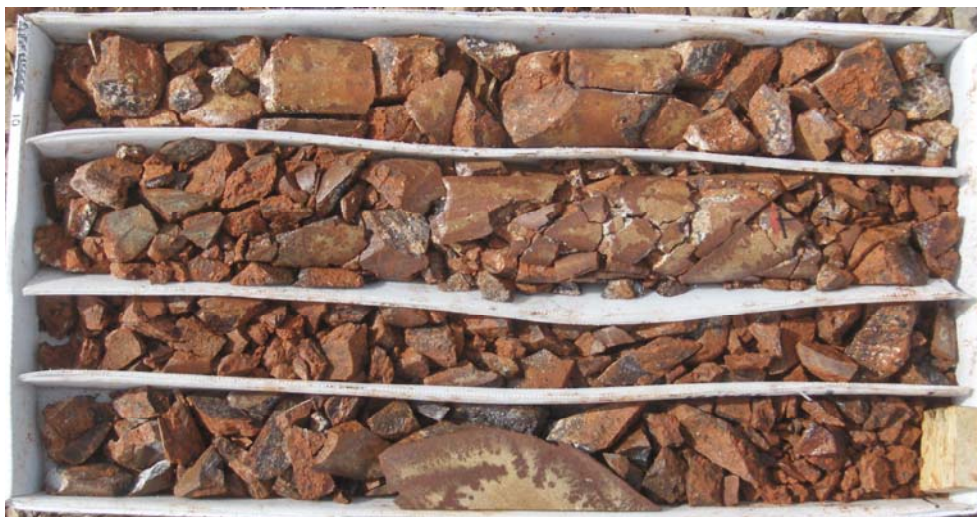
Figure 40B: Photolog of the same drillcore as seen in Figure 40A, taken during AMEC's January/February 2012 site visit

The extent of in-box mechanical degradation seen in the drillcore is emphasized by the photo-pair presented as Figure 40A/B. Figure 40A shows the drillcore shortly after it was drilled in 2010. It appears to be closely jointed because weathering along microveinlets, as evidenced by the presence of limonite and iron oxide staining, has caused them to open-up within the generally weathered section of altered and weathered andesite. Despite this, the core is still largely intact. Figure 40B shows the same drillcore that was photographed during AMEC's January/February 2012 site visit. The extent to which it has degraded through mechanical attrition is self-evident.
