La Preciosa Project

Preliminary Mineability Assessment

Submitted to: Orko Silver
Date: April 13 2012
From: Stephen Godden, AMEC

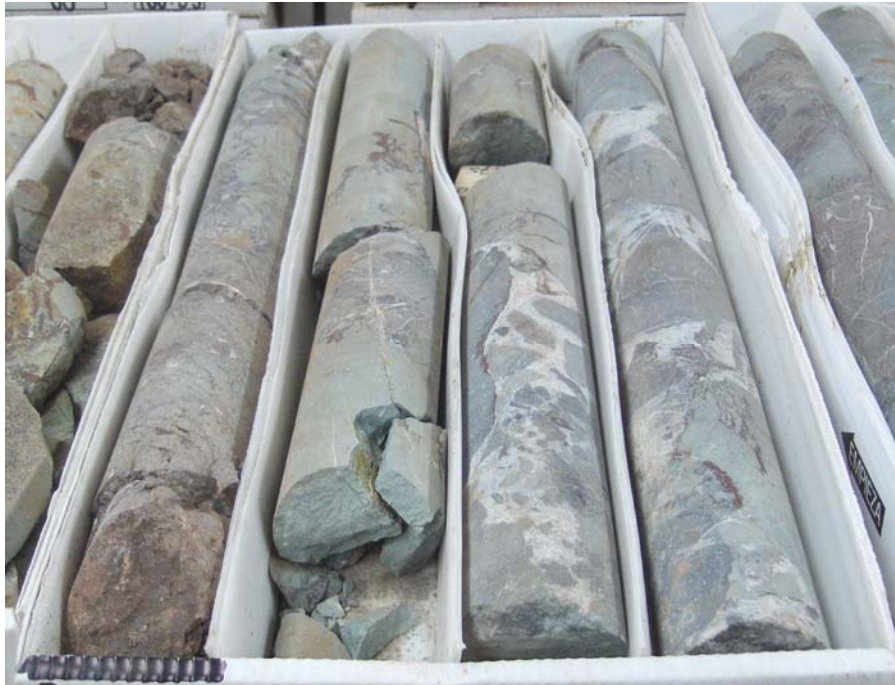
Figure 3: A Silicified Fault Breccia in a Sequence of Partial Altered (Chlorite) Andesite Tuffs

*(drillhole BP10-560, Box 80 – 174.35 m to 176.45 m, top of section at bottom left)
(taken during AMEC's January/February 2012 site visit)*

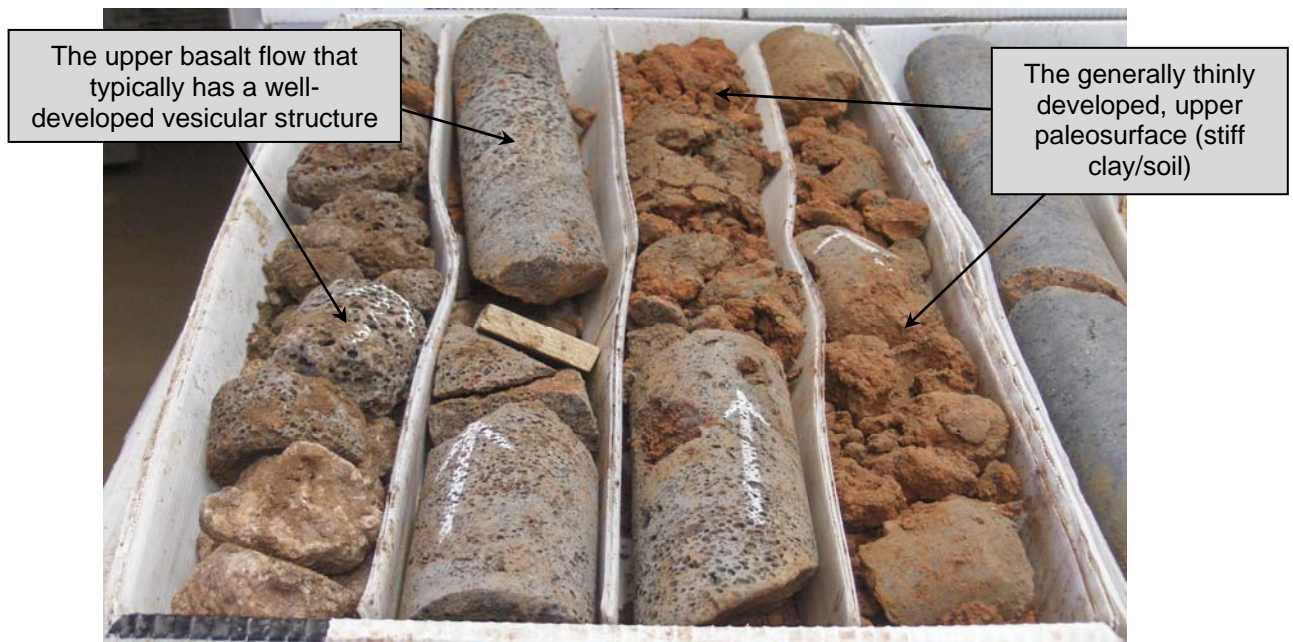
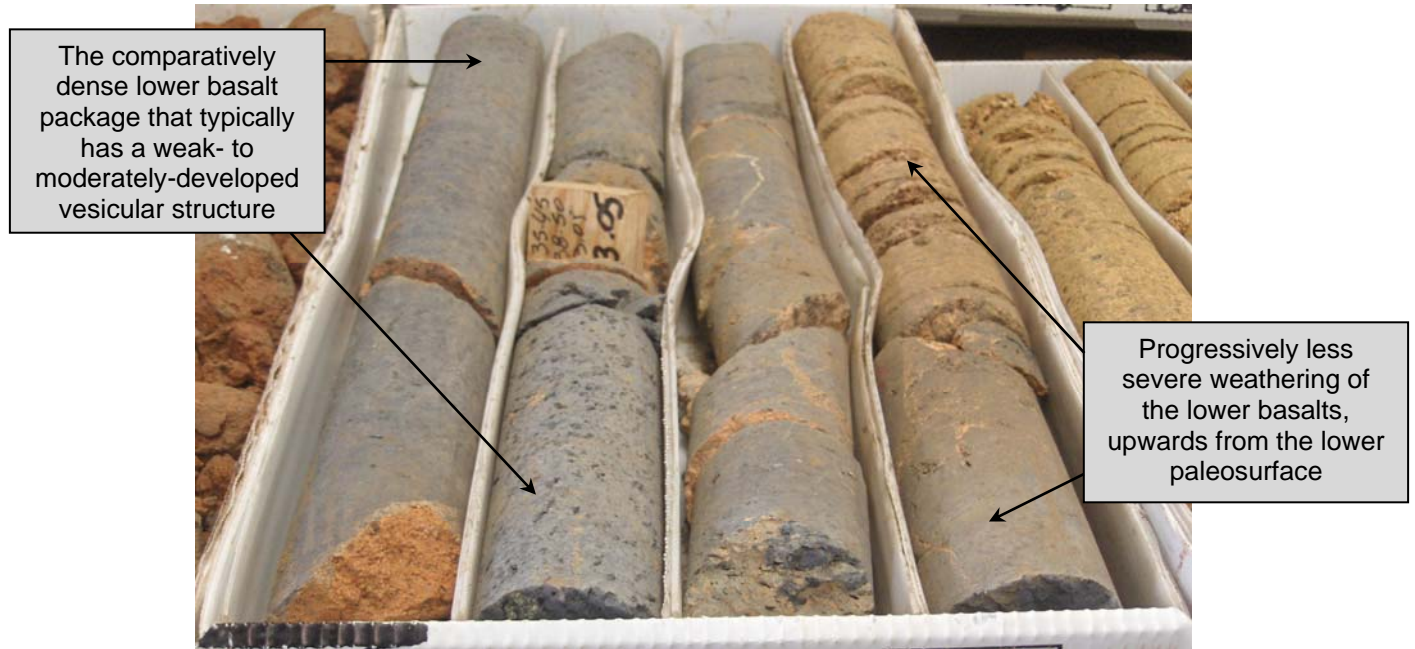
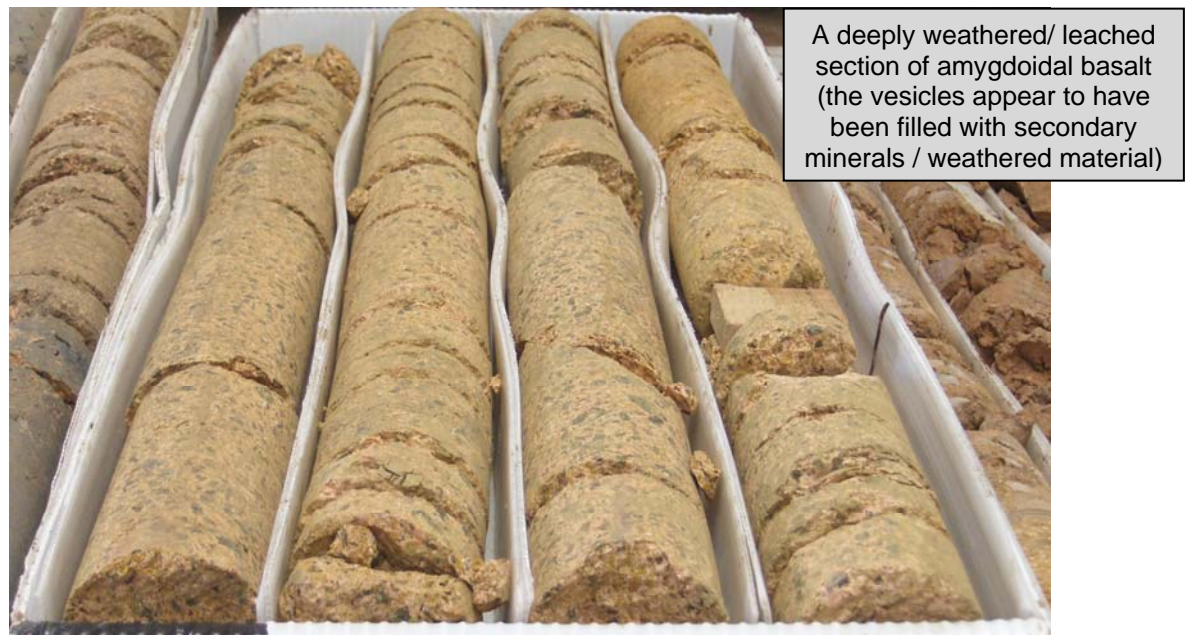
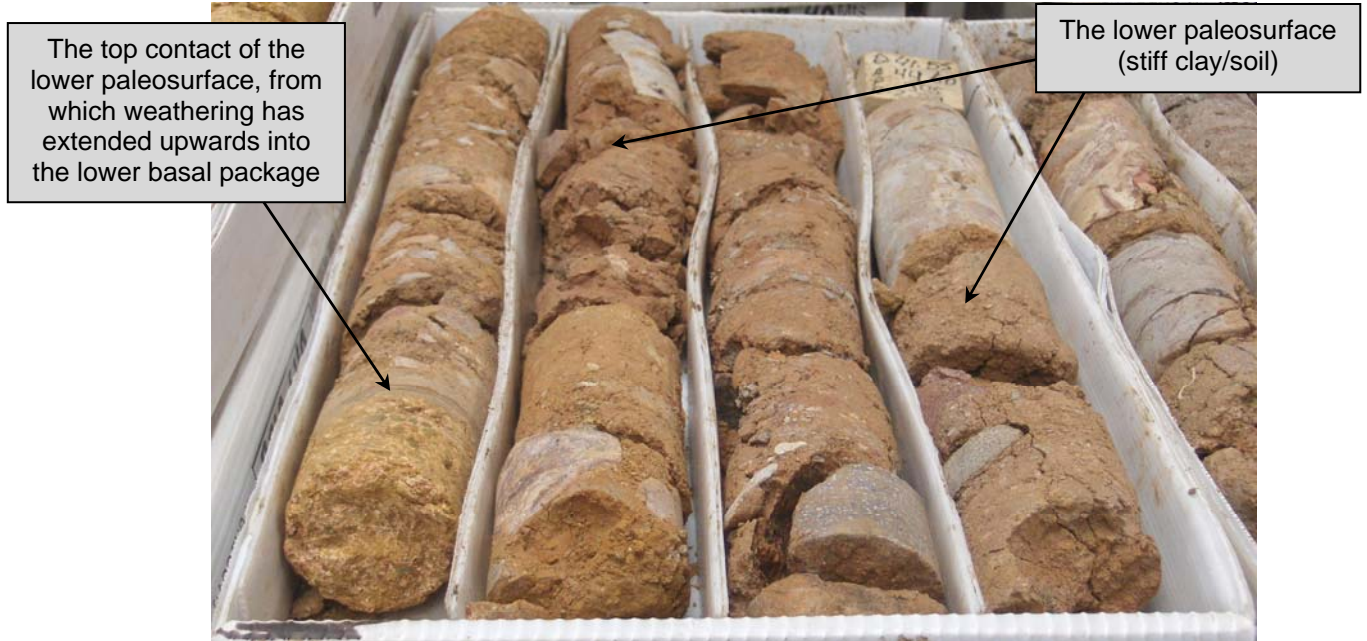
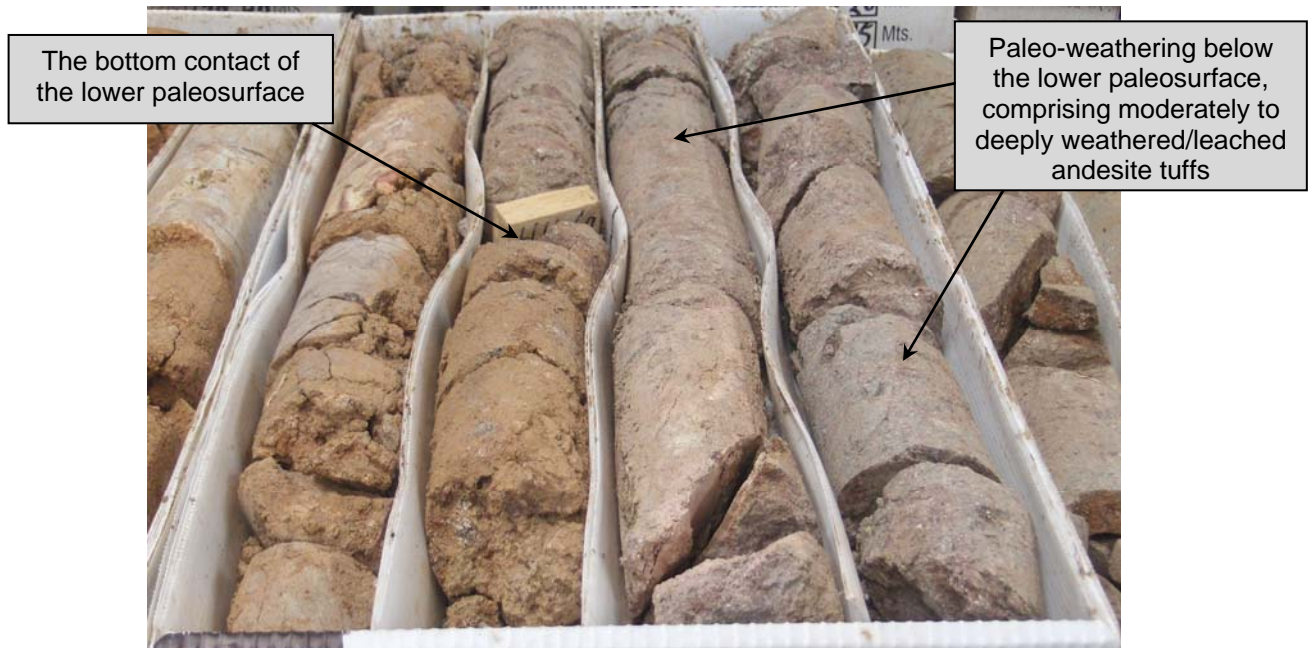
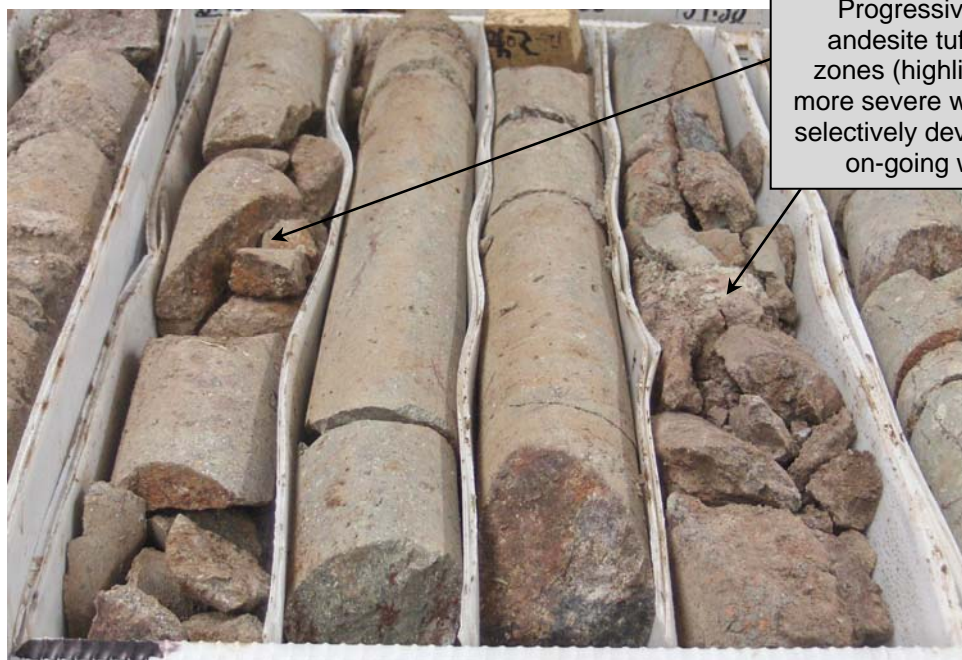
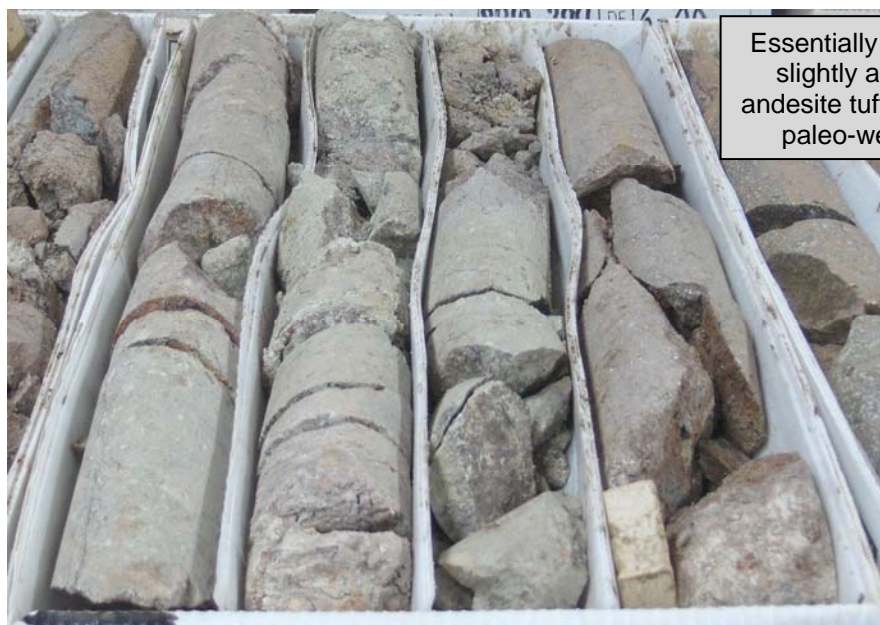
The LVS-basalt unconformity is marked by a generally well-developed paleosurface that comprises a stiff clay/soil with occasional small boulders of silicified material and weathered andesite. Weathering typically extends up into the immediately overlying basalts, for a few metres. Paleo-weathering is evident for up to 15 m below the paleosurface (for example, Figures 12A to G & 13A to F), although the extent and severity of weathering is increased by current/modern-day weathering activity, where the paleo-weathering zone is close to surface.

Figure 12A to G: An Example of a Paleosurface and Paleo-Weathering Zone
(drillhole BP10-560, 0.00 m to 54.25 m, with the lower basalt sequence from 3.30 m to 39.80 m missing)
(taken during AMEC's January/February 2012 site visit)

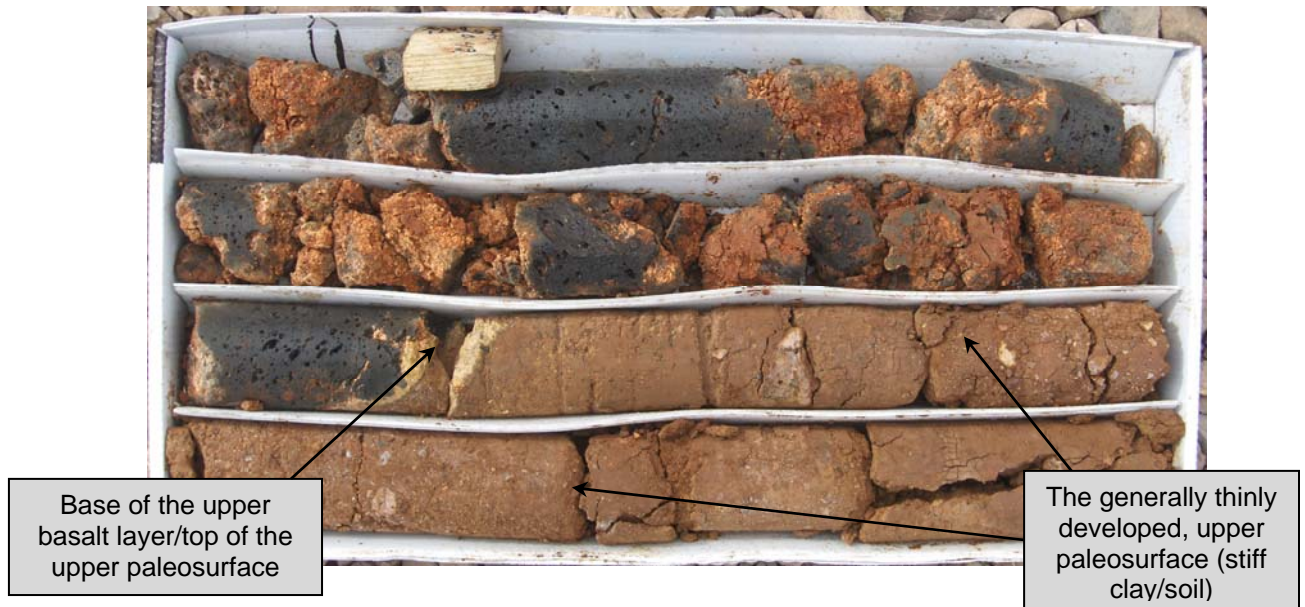
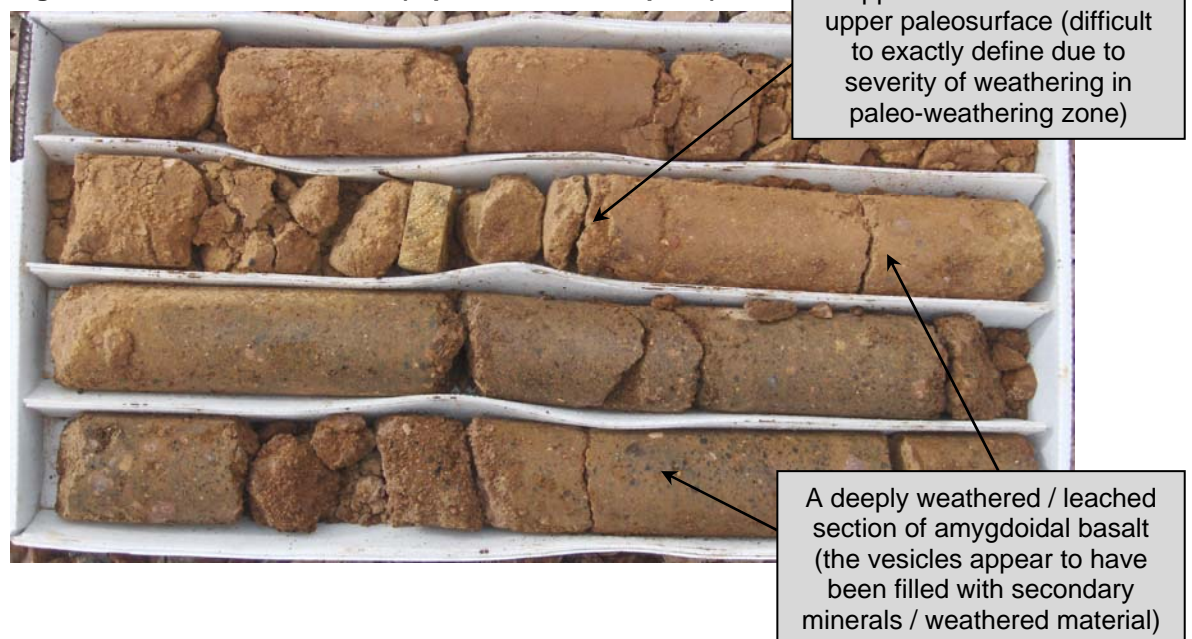
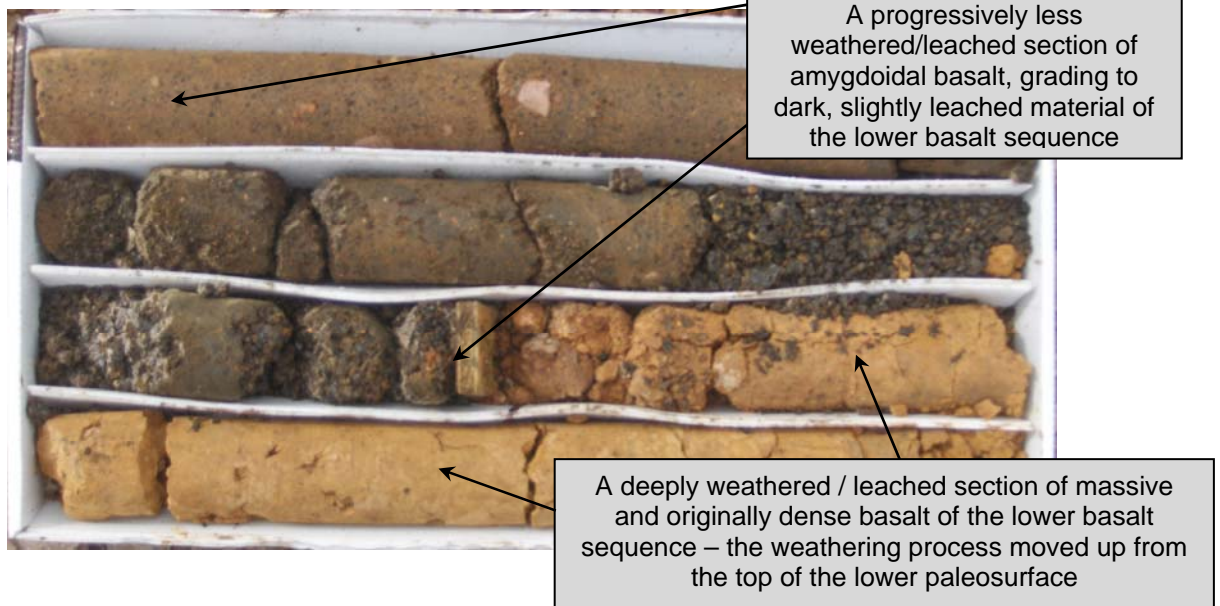
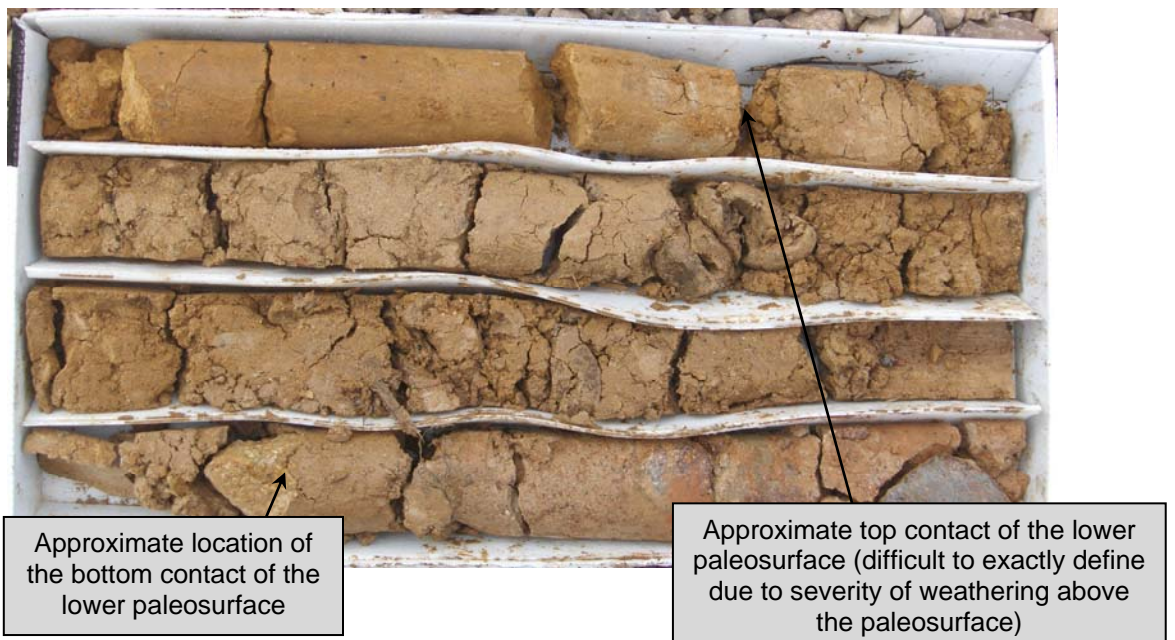
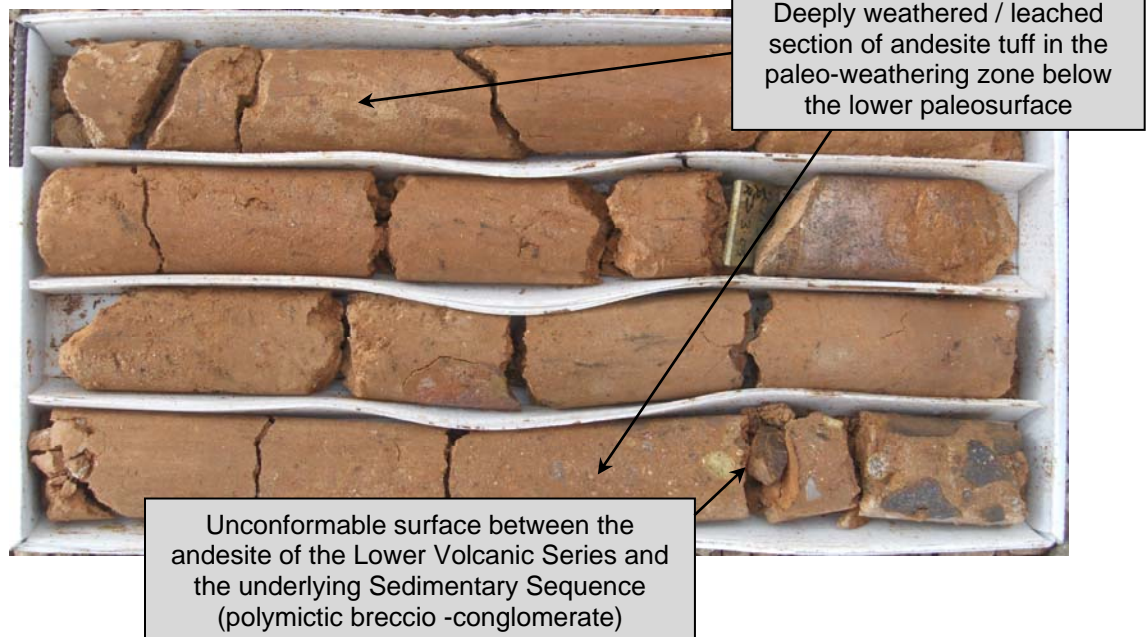
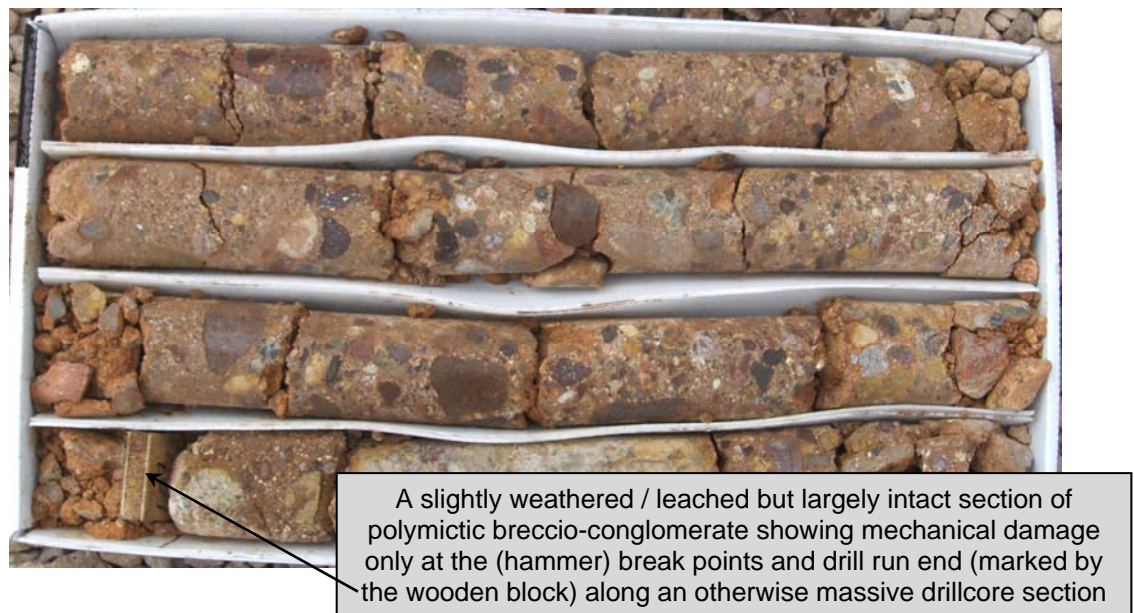
Figure 13A to F: A Second Example of Paleosurfaces and Paleo-Weathering Zones
(drillhole BP09-431, 20.35 m to 33.10 m)
(taken during AMEC's January/February 2012 site visit)

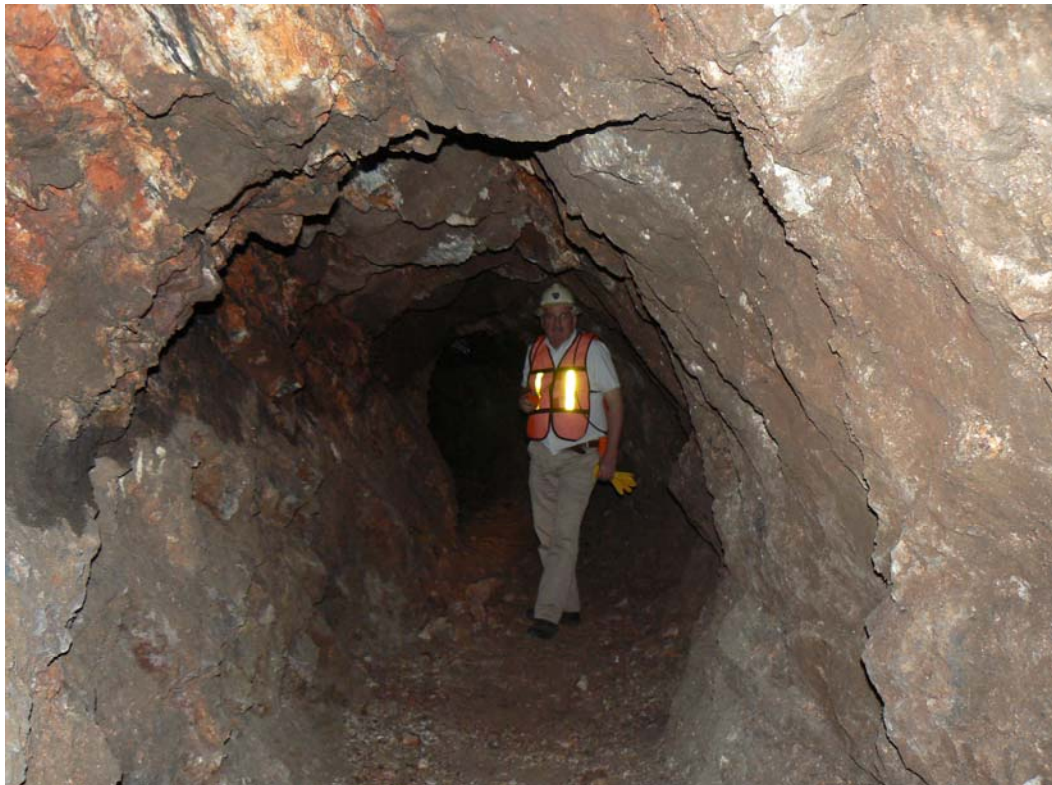
There are some 2.5 km of underground drifts and associated stopes that follow the Abundancia and La Gloria veins, as well as a small portion of the Transversal vein. The original workings comprise drifts that are up to approximately 1.9 m high and approximately 1.5 m wide (for example, Figure 15) that are reported by Orko Silver Corp. to be over 100 years old.

Figure 15: An Example of the Early, Abundancia Vein Workings at La Preciosa
(taken during AMEC's early January 2012 site visit)

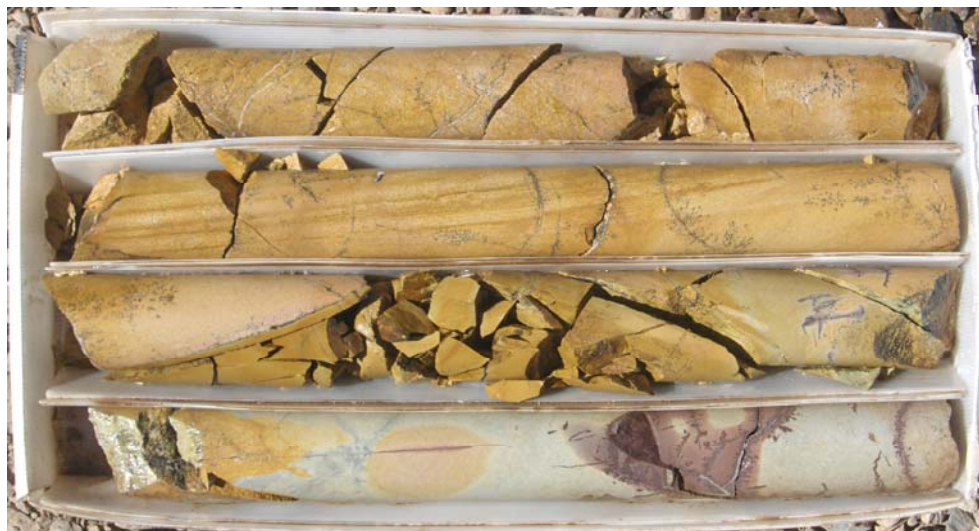
Figure 24: An Example of Local Weathering / Leaching of an Otherwise Intact and Fresh but Locally (hematite) Altered Andesite Tuff of the LVS
(drillhole BP05-006, 105.70 m to 107.95 m, top of section at top left)
(taken during AMEC's January/February 2012 site visit)

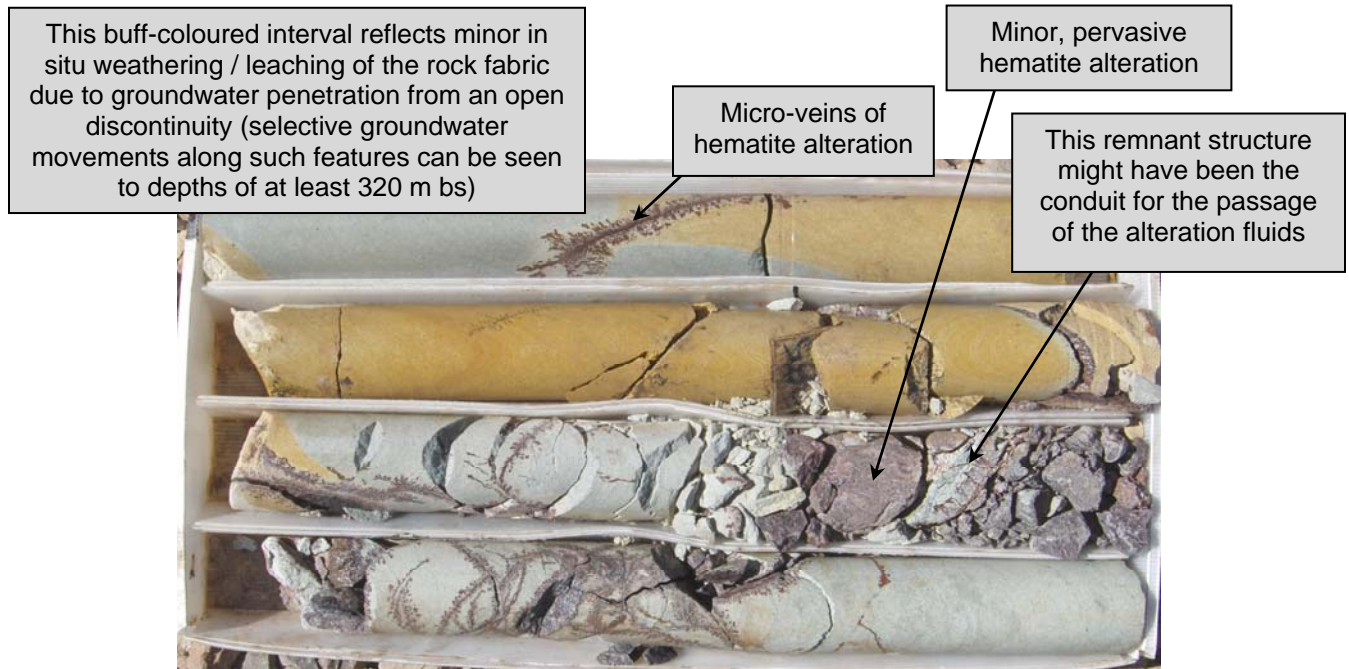
Hematite alteration appears to be sporadically developed throughout the LVS. At its lowest intensity it appears as micro-veinlets marked by dark red to purple infillings and minor wallrock penetration of the alteration fluids (for example, Figure 28). With increasing severity, minor pervasive alteration develops (for example, Figure 29). Where severe, pervasive alteration occurred the affected drillcore sections can degrade in-box, insofar as opening along alteration-related micro-fractures tends to occur, reducing what might otherwise be largely intact drillcore lengths to loose masses of angular fragments. With the addition of water (as a result of drilling, during logging, in preparation for core photography or during drillcore splitting) or as a consequence of progressive in-tray degradation under the influence of atmospheric moisture, pervasively altered rocks can eventually break-down to closely fragmented masses with little or no intrinsic strength.

(drillhole BB05-006, 116.43 m to 118.61 m, top of section at top left)

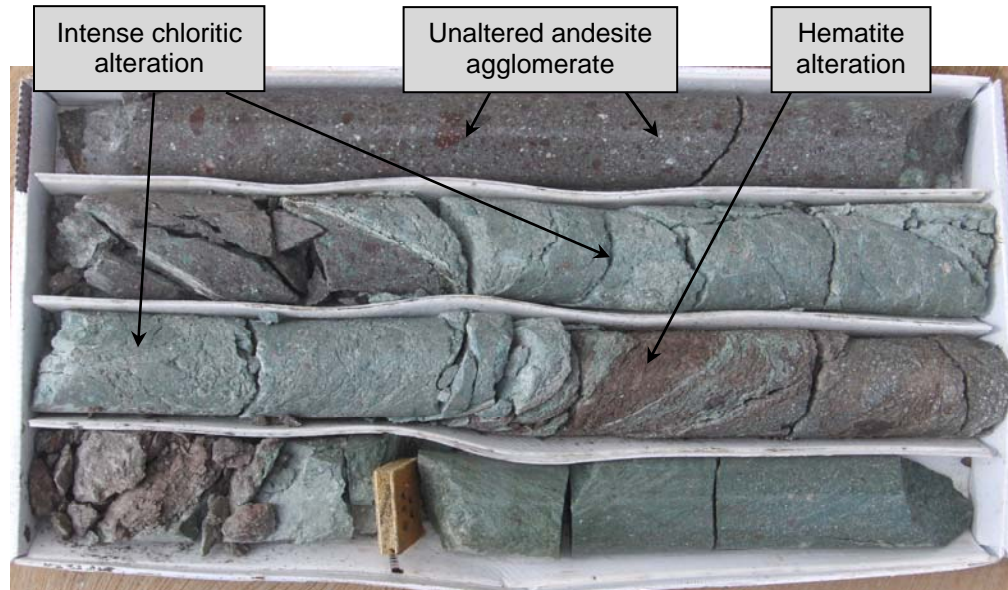
Locally intense chloritic alteration was seen along short drillcore lengths, in what appear to be narrow, discrete zones within andesites of the LVS. Figure 32 provides an example of this, from which it can be seen that the affected drillcore is breaking-down into a weak, loosely consolidated mass.

Figure 32: An Example of Locally Intense Chloritic Alteration of an Andesite Agglomerate of the LVS
(drillhole BP09-431, 161.85 m to 164.00 m, top of section at top left)
(taken during AMEC's January/February 2012 site visit)

A remnant structure is apparent in the altered section shown on Figure 32, which may be weak foliation or an expression of ductile deformation. This suggests that the observed alteration might be closely confined within the original hot-fluid conduit. The close proximity of apparently fresh and unaltered andesite tends to confirm this assumption, hence the potential for continuous structural conduits that might originally have been fault- or shear-zones. Whatever the case, AMEC recommends that the continuity of these structures should be assessed through three-dimensional analysis of drillcore intersections. This key point is emphasized because if the alteration is confined to persistent conduits, they could act as planes of preferential rockmass parting that could affect the bulk stability of either open pit slopes or underground stopes, depending on their position or positions relative to a planned or mined excavation.

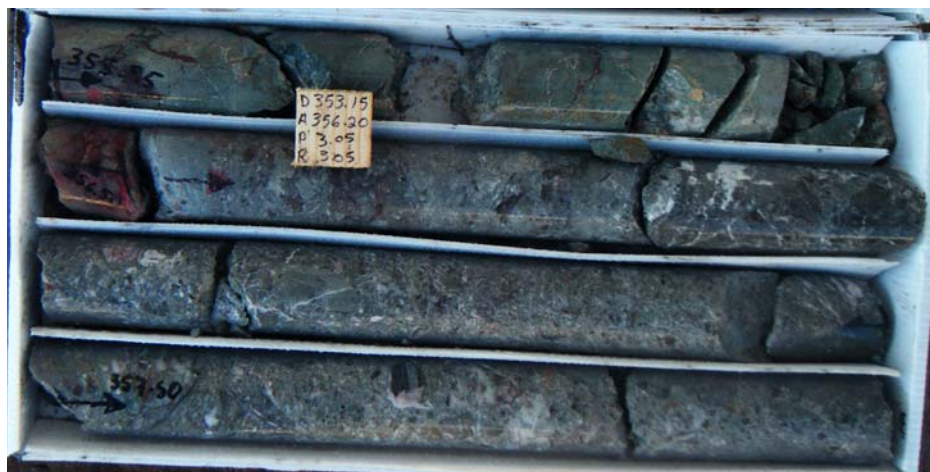
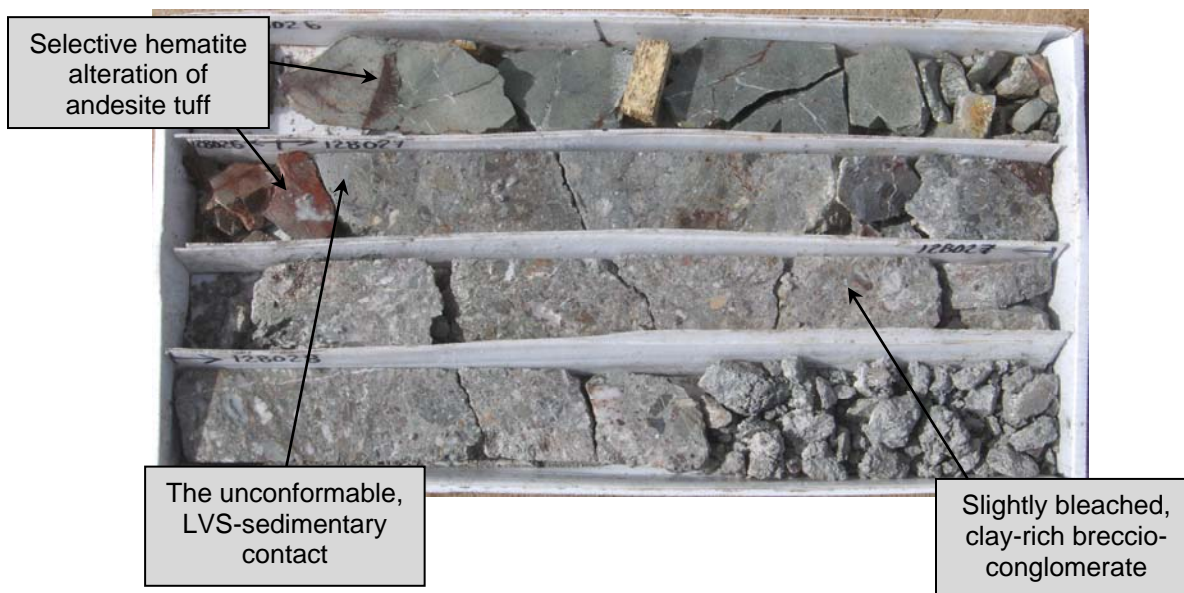
Figure 33A/B: Drillhole BP10-673, 355.95 m to 358.10 m
(top of section at top left in either case)
(note the hematite alteration of andesite, which alteration
(type/mineralogy is lacking in the breccio-conglomerates)

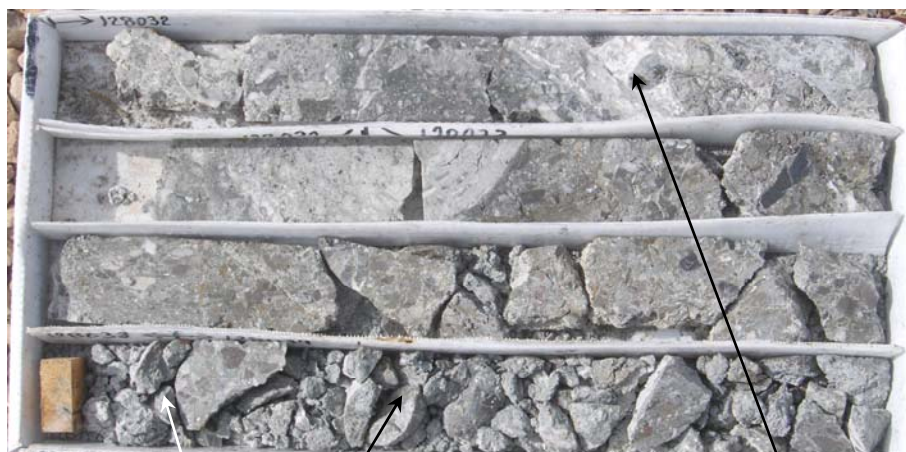
Figure 35B: photolog of the same drillcore as seen in Figure 35A, taken during AMEC's January/February 2012 site visit

Moderately altered material,
marked by numerous cross-cutting
microfractures infilled with fine
grained alteration minerals

Minor zone of
silicification /
quartz veining

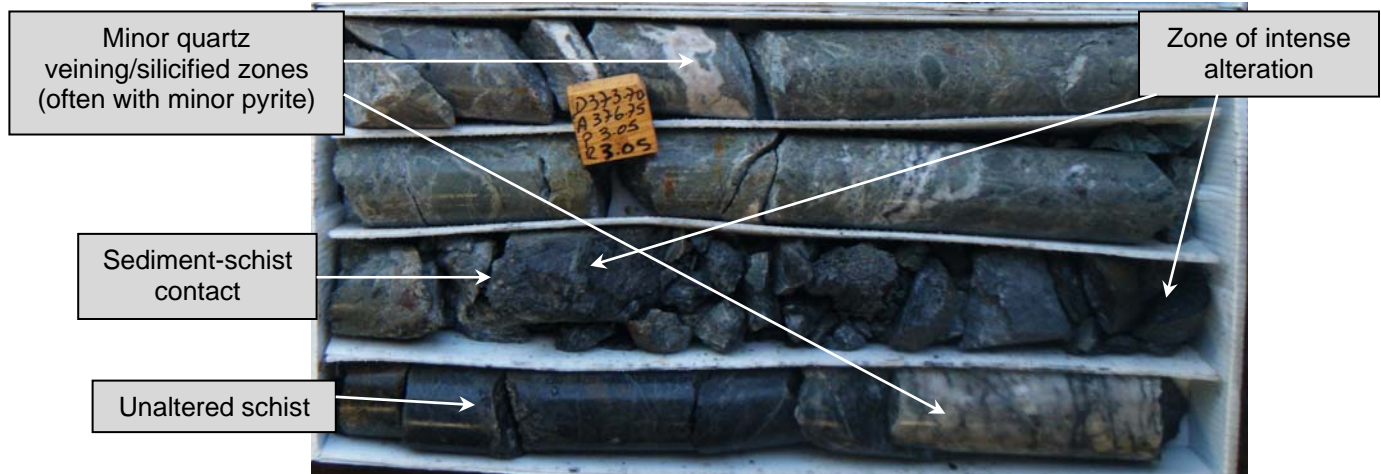
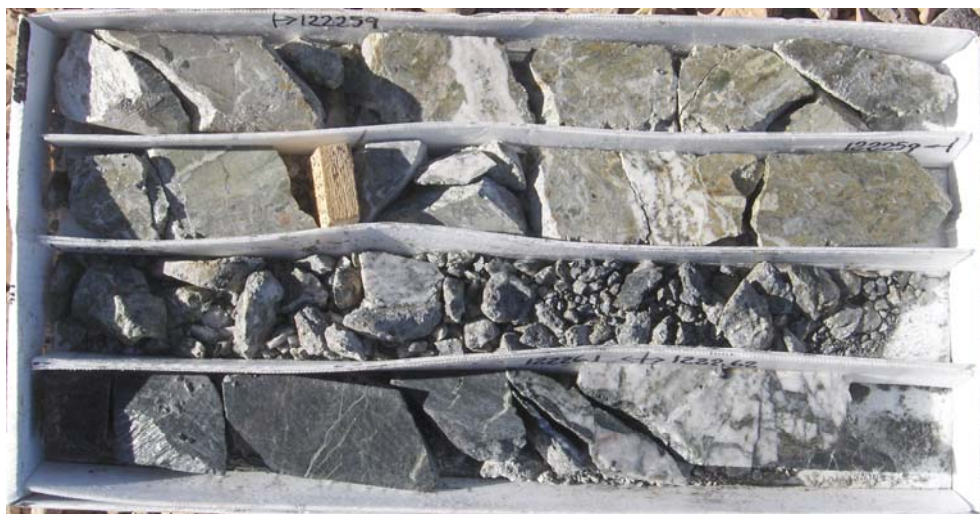
Figure 37A/B: **A Photolog of Severely Altered Schists Immediately Below the Nonconformable Schist-Sediment Contact**
(drillhole BP10-560, 376.00 m to 378.15 m, top of section at top left)

(total core recovery = 90.7% with an estimated 0.2 m lost)

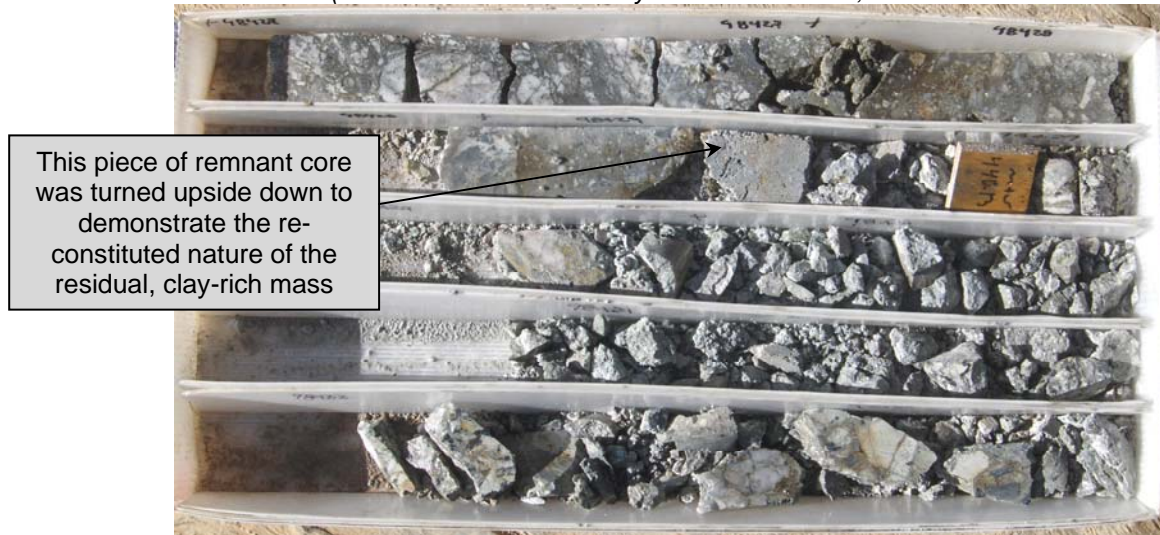
Figure 38A: Drillhole BP08-254 - 439.11 m to 441.72 m (top of section at top left)

- the 'A' photograph taken in 2010, shortly after the hole was drilled, reflects weak ground (drilling-related damage is evident and minor core loss was reported); however
- after the core had been logged, split and stored in core boxes for at least a year it had degraded to a loose, clay-rich mass that had in part reconsolidated to a stiff, dry mass (see Figure 37B, which remnant drillcore characteristic is also seen in BP08-254, as suggested by Figure 38A/B).

(estimated total core recovery = 85.4% in this box, with an estimated 0.34 m lost)

Approximate position of the nonconformable schist-sediment contact (note the variously silicified nature of the bottom section of conglomerate, which can extend into the schists and can contain pyrite)

AMEC interprets the drillcore degradation process as being the same as, or at least similar to, that described for clay-altered sections of the sedimentary sequence: degradation caused by the action of water on a weathering-susceptible alteration mineralogy. However, as earlier outlined, clay is not usually associated with propylitic alteration-related mineral assemblages. A number of alternative sources could therefore in theory apply. For example:

- special measures would have to be taken to ensure stable pit slopes that could selectively fail by sliding either along or around the nonconformable contact area (the likelihood of such failures depends on the local pit wall and contact geometries and the local continuity of the altered/clay-rich contact zone); and

- the alteration/clay-rich zone would have to be sealed with a chemical sealant and an aggregate working floor thrown if the contact zone was at or near to the footwall elevation of any planned stopes or drifts (which floor would also have to be thrown if the footwall any planned stope or drift was located on or the schists, to preclude excessive slippage hence tire wear and damage to the differentials of trackless production equipment).

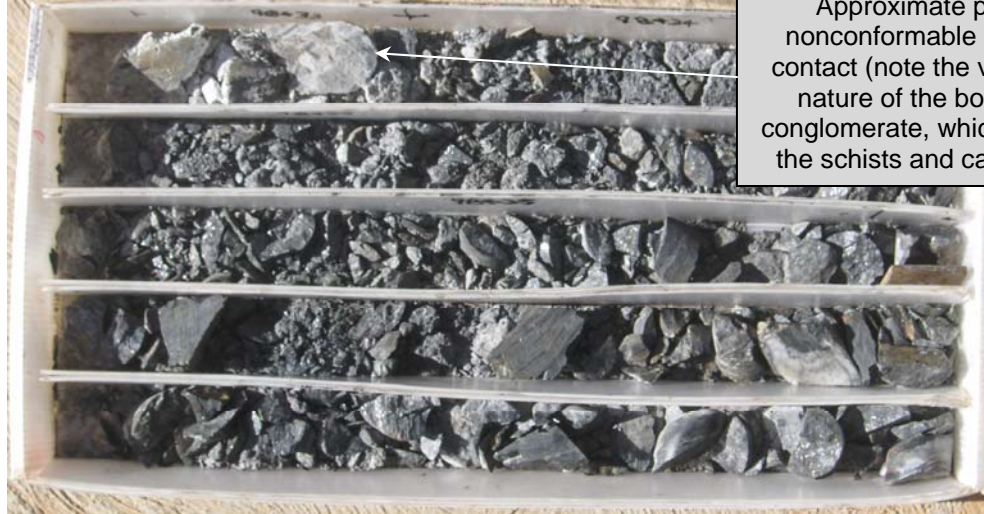
Figure 38B: Drillhole BP08-254 - 441.72 m to 444.38 m (top of section at top left)

(estimated total core recovery = 100% in this box)

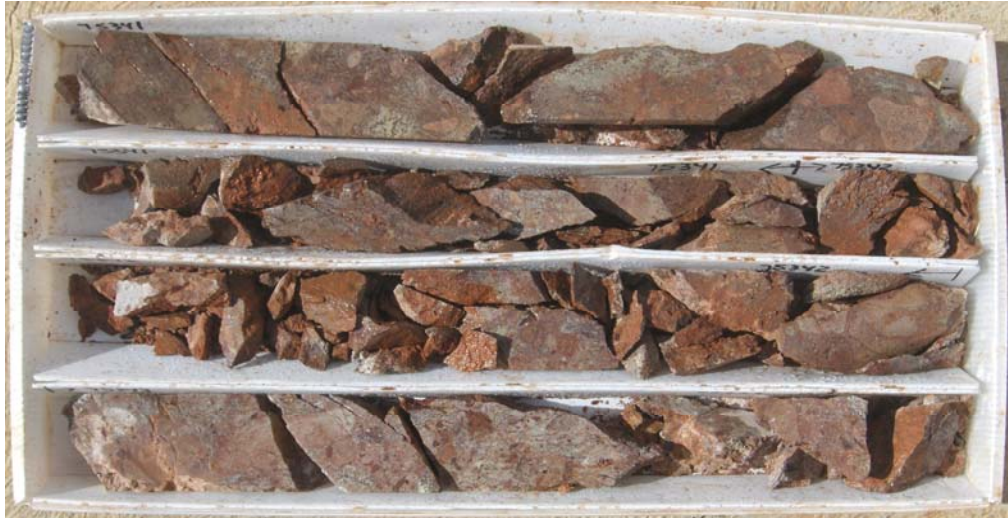
The importance of close examination and interpretation of the available drillcore, rather than detailed geotechnical logging aimed at defining average rockmass ratings, is further emphasized by the extent of drilling-related and in-box mechanical degradation of the examined drillcores. The effect of drilling damage on vein intersections is emphasized in Section 5.1.3. Similarly extensive damage can also be seen where loose / open, sub-vertical and undulating discontinuities of the type described in Section 3.1 are intersected, especially where cross-cutting discontinuities are developed. This is a common drillcore characteristic when high bit pressures are used, as is inevitably the case when the emphasis is on production drilling for drillcore metres. Figure 39 provides an example of the type of outcome drilling-related damage can cause, although at least some of observed degradation almost certainly occurred in-box.

Figure 39: An Example of Extensive Drilling Damage to a Section of Slightly Altered (Hematite), Andesite Agglomerate Drillcore Affected by Steeply Inclined, Irregular Discontinuities, with Minor Limonite Infilling
(drillhole BP08-211, 87.23 m to 89.27 m, top of section at top left)

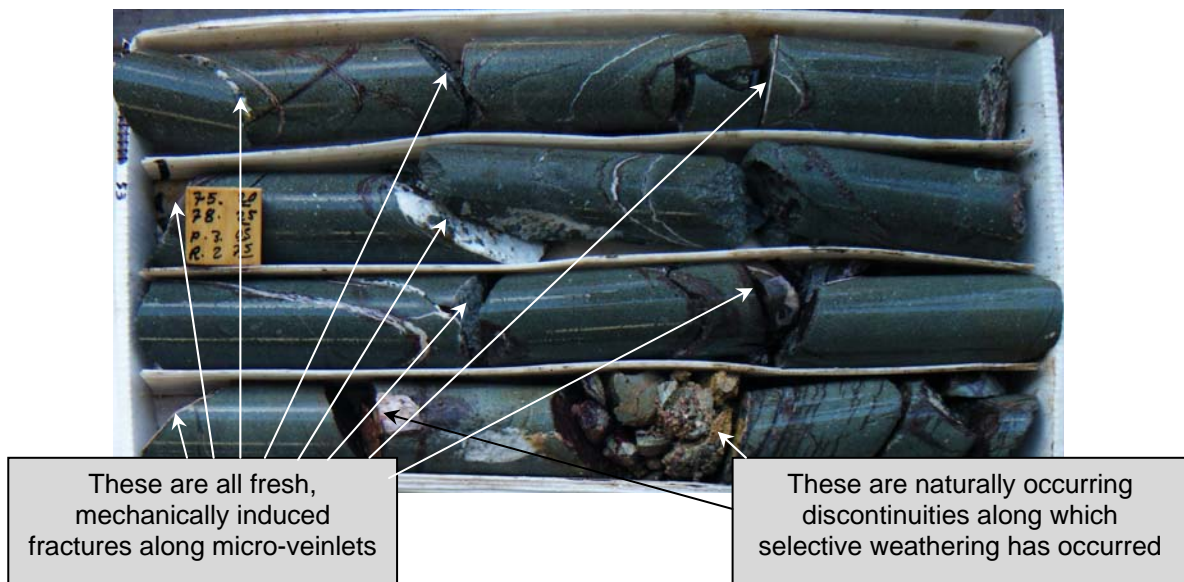
Figure 41A: photolog taken in 2010 (supplied by Pan American Silver)

In-box mechanical degradation of drillcore is also apparent along drillcore sections that are affected by micro-veining. Figure 41A/B provides an example of this – although selective weathering due to the presence of groundwater is evident in the core, AMEC interprets all the other fractures to be mechanical breaks of what in situ would be competent, massive rock. This interpretation is made because:

- there is no evidence of weathering (limonite or iron staining) along the calcite infilled micro-veins, which might reasonably be expected given the extensive and deep penetration of groundwater into the general rockmass (although a slight reduction in the strength of the mineral infilling can be seen, as evidenced by its reduction to somewhat loose, fine grained material);
- the characteristics of the vein-associated fractures are identical to those when a new fracture along a previously intact micro-vein is made; and
- reference to photologs of similarly veined drillcore sections, taken shortly after the core was drilled, show them to be intact.

Figure 41A/B: An Example of Significant In-Box Mechanical Degradation of Micro-Veined Drillcore
(Drillhole BP10-549, 77.65 m to 79.97 m, top of section at top left in either case)
